# WATERSHED SURVEY FINAL REPORT & ACTION PLAN

LAKE WARNER / MILL RIVER WATERSHED  
AMHERST, HADLEY, LEVERETT, AND SHUTESBURY, MASSACHUSETTS  
FALL 2002 – WINTER 2003

## Lake Warner / Mill River Watershed Survey Final Report

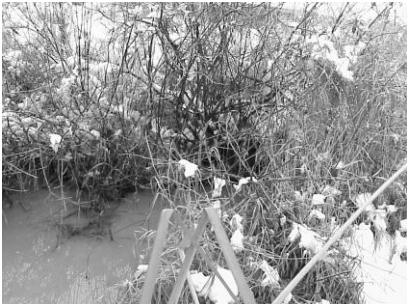
Perhaps the clearest example of direct flow of discolored water into the wetlands is evident near the south side culvert off the jogging track west of Alumni Stadium (photo #1 and #2).

2) Discolored water entering wetlands from culvert on the south side of the jogging trail west of Alumni Stadium.

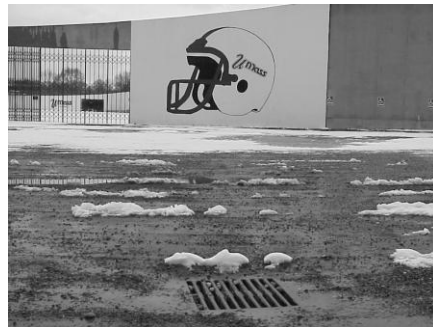
4) Source of discolored water discovered just south of Alumni Stadium where storm drain receives the runoff from a trap rock parking lot.

- Section 8 – Stop & Shop & CVS – Install BMPs that effectively buffer stormwater and allow proper infiltration.
- Section 11 - UMass Campus – Work to reduce impacts of runoff from unpaved parking lots south of the stadium

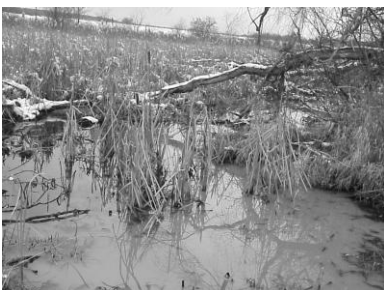
3) Murky water merges with clear water in streambed west of Alumni Stadium

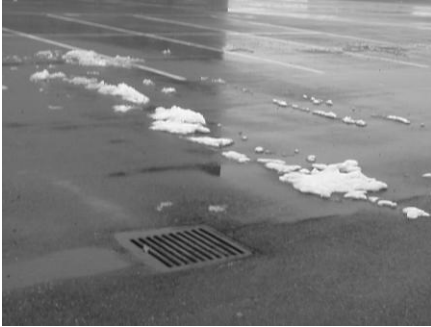
5) Storm drain to the north of stadium receives water not discolored with sediment.

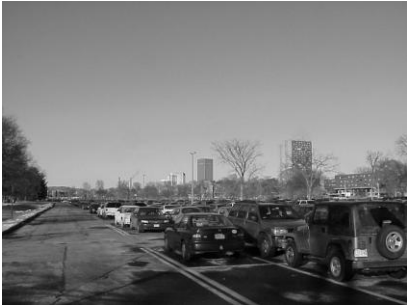
6 A) Parking lot just southwest of Southwest Towers (UMASS): Another potential problem area is the proximity of the dumpster and parking lot behind a fraternity on Pleasant Street, Amherst to the stream running from McClellan Street to just south of the visitor parking lot off Massachusetts Avenue.

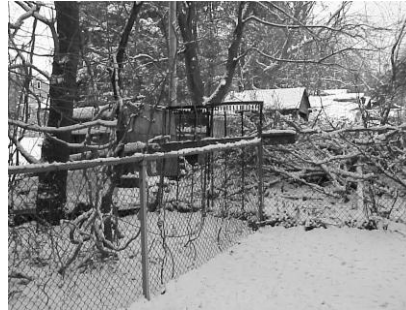
11) Rear of 85 Fearing Street property.

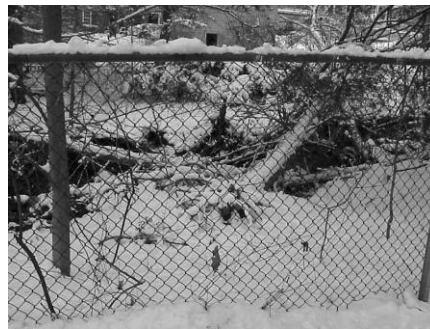
These trees have fallen into the stream between Fearing Street and Pleasant Street offering squirrels an excellent opportunity to cross the waterway.

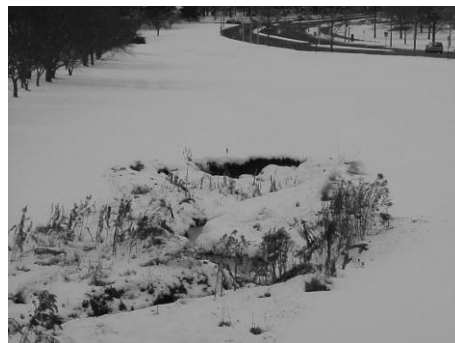
9A) Either soil caves into the stream on the north side of Massachusetts Ave. just east of the intersection of Mass Ave. and Mullins Way or the snow has covered a concrete culvert ( something to check out at another time).

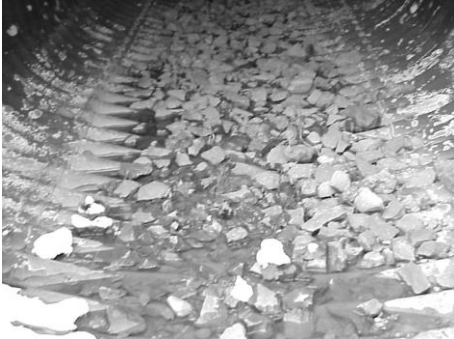
9) Keep an eye on the culvert under Mullins Way where rock used in rip rap has collected in the bottom of the culvert.

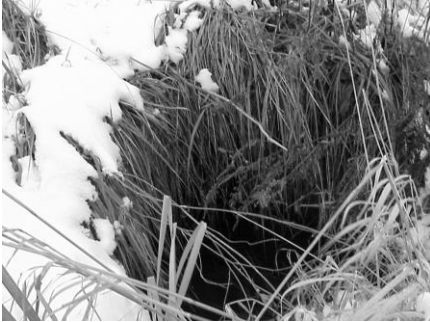
13) Finally, keeping an eye on the overgrowth of culvert #1, just off Rocky Hill Road may be a good idea since the grasses have overgrown the culvert and threaten to impede the flow.
