# STATE OF THE LAKE REPORT 2015

Lake Warner, Hadley Massachusetts

Jason L. Johnson, Executive Director  
Friends of Lake Warner and the Mill River  
for the Town of Hadley, Massachusetts

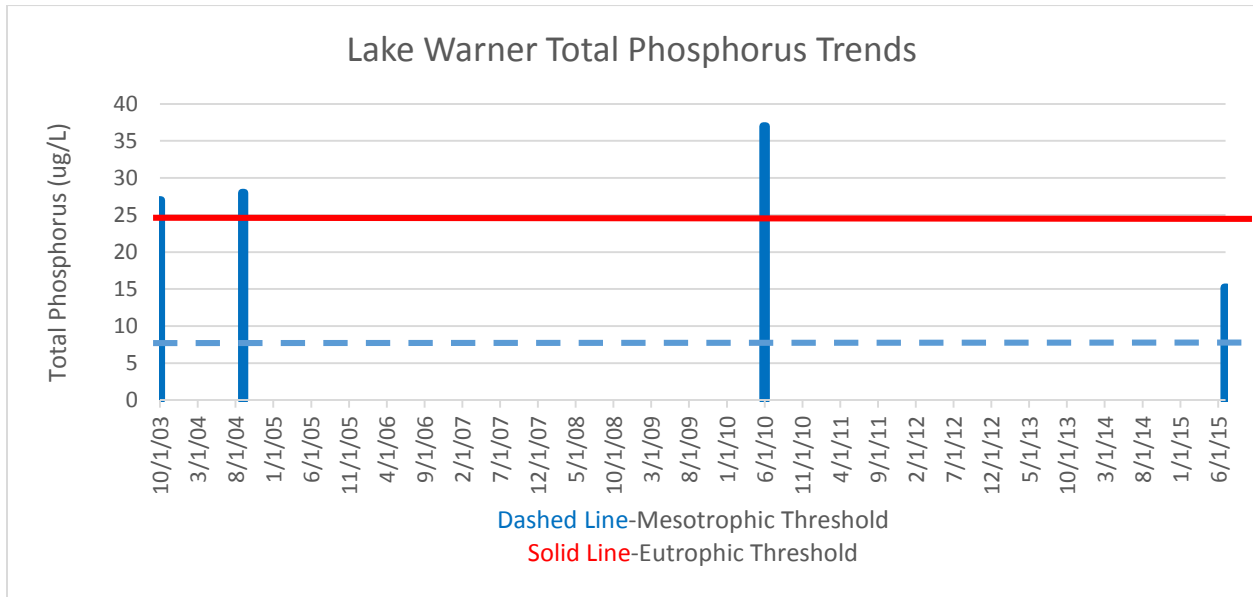
Figure 3. Total Phosphorus Trends Lake Warner 2003-2015

Note on Fig 3: Values from 2003 and 2004 are geometric means of several samples during that season. 2010 value is a single sample taken by Ethan Needu during sampling for a Zebra Mussel Study. Similarly the 2015 value is from a single sample and may not be representative of the conditions during the rest of the year.

Phosphorus is the limiting plant nutrient in lake ecosystems. Excessive amounts are a primary cause of eutrophication (nutrient enrichment). Phosphorus levels were measured at the mid lake site and upstream on the Mill river and other tributaries. Levels in the lake were very low, at times below levels of detection. Levels of Phosphorus were higher in the Mill River above the lake. The results are not refined enough to determine sources. Perhaps due to a relatively dry summer Phosphorus measurement from the lake was not elevated. However there are elevated inputs from tributaries and the Mill River was often higher than the EPA's threshold levels for streams and rivers. Phosphorus results can be found in Table 2, and Figures 3, 4 and 5.

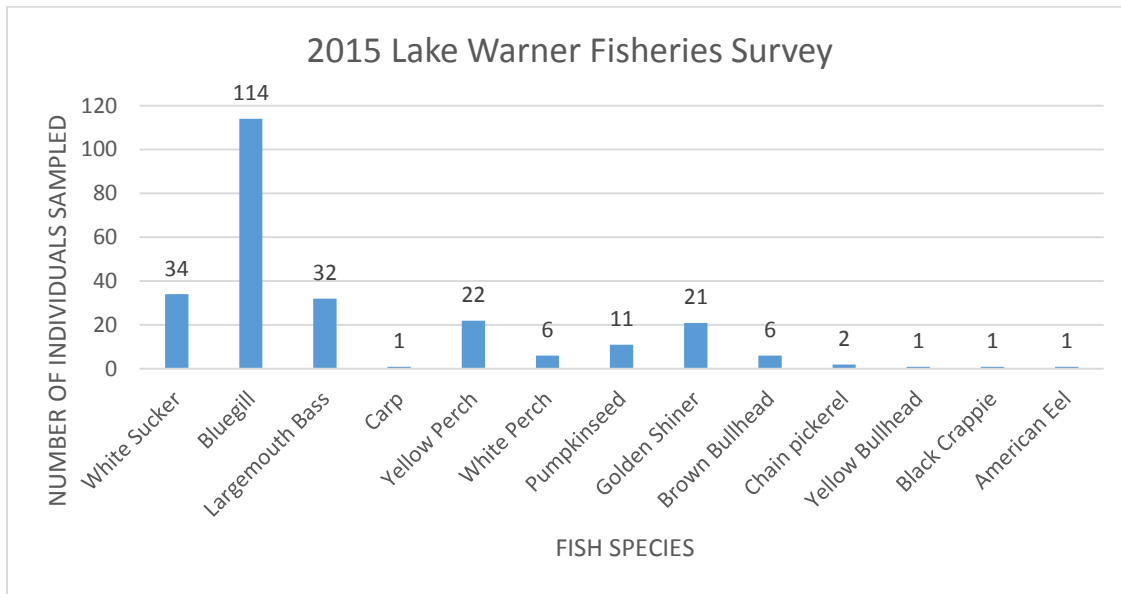
Figure 6. 2015 Fish Species Sampled in Lake Warner

The Massachusetts Division of Fisheries and Wildlife conducted an electrofishing survey of Lake Warner in June. Figure 6 shows the 13 species collected during this survey. This sampling effort was not intended to provide a population estimation of the lake or to predict fisheries production in the lake. It provides a "snapshot" of lake conditions at this time. The high diversity of species collected, the large size of individual bass collected and quantity of forage fish indicate a very productive lake ecosystem, with a high diversity of native fish species and self-reproducing populations of historically stocked species. Lake Warner has not been stocked by MAFW since 1962 and 1963 when (1,345) and (1,100) Largemouth bass were stocked following the reclamation of the lake. Figure 7 shows the size and weight of the largemouth bass surveyed in the lake in 2015.

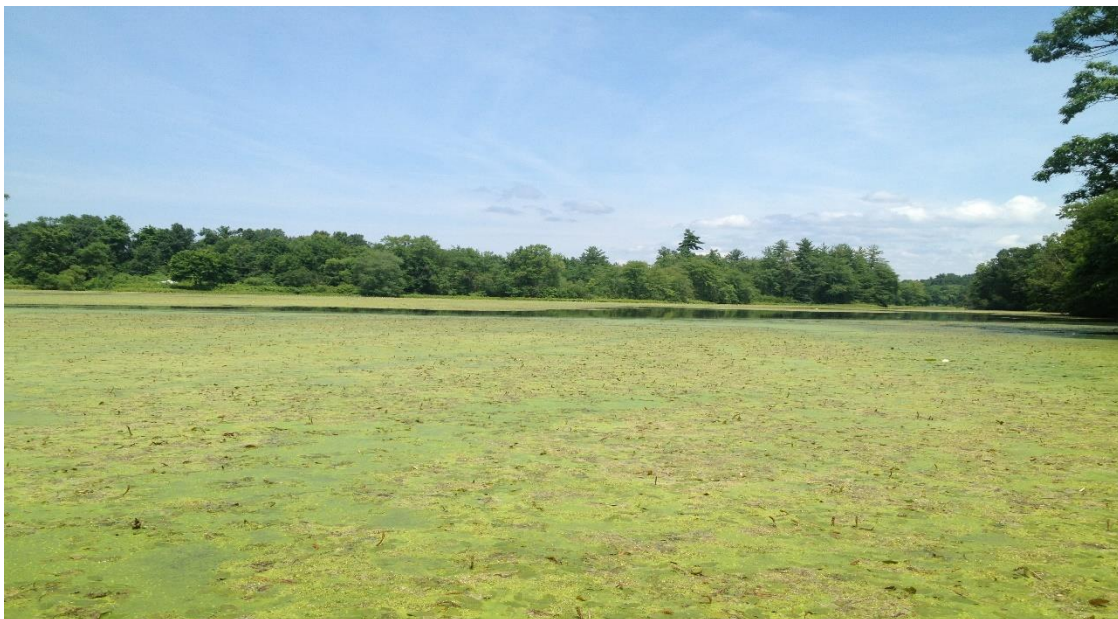
Lake Warner in late summer during peak of aquatic vegetation growth. Uncontrolled nuisance aquatic vegetation and algae is preventing light transmission into the lake causing low dissolved oxygen levels that impair lake health. August, 2015  
(Photo by Jason L. Johnson)

Extreme plant growth in aquatic systems is referred to as nuisance aquatic vegetation. Controlling nuisance aquatic vegetation has been recommended in Lake Warner in every survey or evaluation of the pond since the 1950's. The next steps are to complete the documentation and mapping of the vegetative communities present in the lake, and to produce an Aquatic Vegetation Management Plan that is accepted by the Hadley Conservation Commission and DEP.
