STATE OF THE LAKE REPORT 2016/2017

Lake Warner

Hadley, Massachusetts

Prepared by Jason L. Johnson, Executive Director
Friends of Lake Warner and the Mill River
for the Town of Hadley, Massachusetts

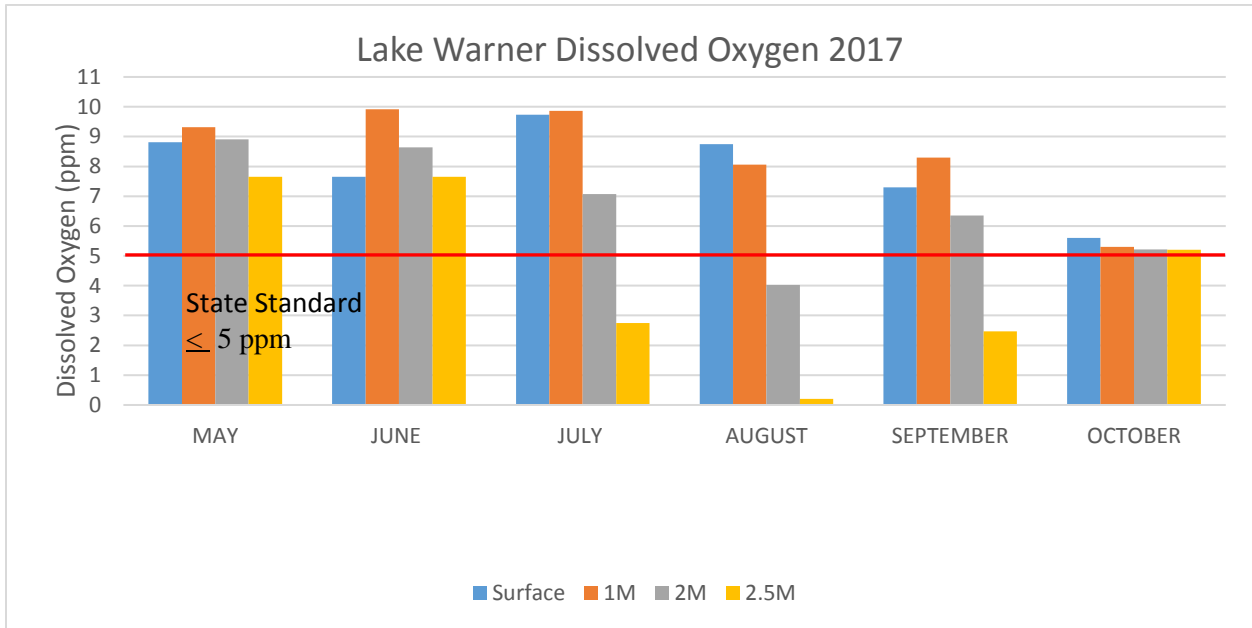
Figure 4. Lake Warner Dissolved Oxygen 2017

During dam repair in 2017 booms were installed near the dam to prevent recreational users from accessing the construction area. The booms prevented floating aquatic vegetation, mainly Wolfia

sp. from being flushed from the system. This created a backup of floating vegetation that extended upstream into the mid lake sample site. Excessive floating vegetation can result in decreased DO levels at depth as well as contribute to super saturated conditions near the surface. Precipitation in 2017 was above average, maintaining overall cooler temperatures and less stressful DO conditions in the lake.
