STATE OF THE
LAKE REPORT 2018
LAKE WARNER
HADLEY,
MASSACHUSETTS

Prepared by Jason L. Johnson, Executive Director
Friends of Lake Warner and the Mill River
for the Town of Hadley, Massachusetts

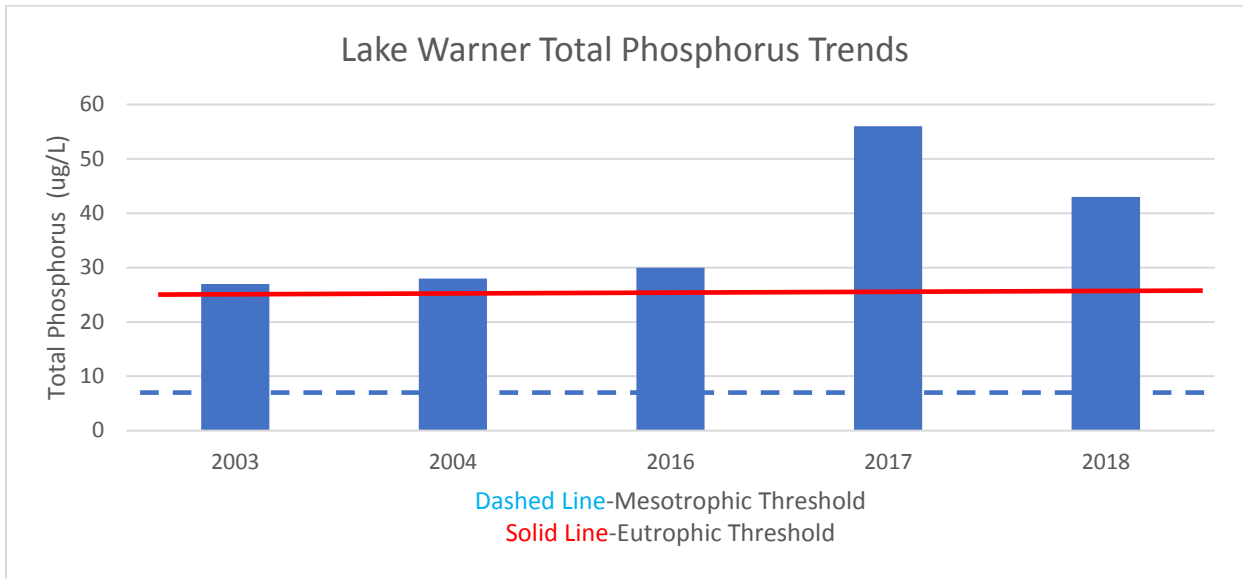
Figure 4. Total Phosphorus Trends Lake Warner 2003-2018

Phosphorus levels were measured ten times at the mid Lake site during the 2018 sampling season. Levels in the lake were 5 times higher than the ecological threshold for lakes in our region. Levels at the mid-lake site exceeded the eutrophic threshold from 2016-2018. Trends from the 2003/2004 study of the lake and this study are presented in Figure 4. Comparisons between 2016 and 2018 are shown in Figure 5. All values are represented as geometric means.

The lake levels from all three years are less than those predicted by the phosphorus model from the TMDL study of 120 ppm. We only sample five months out of the year so actual rates may be higher. The 2018 value of 43 ppm align with the range predicted by Snow and DiGiano of 25-50 ppm. While values presented are geometric means of measurements at those sites, they cannot be taken for annual average values for the tributaries or lake. Nonetheless, the lake values are considerably higher than state and federal thresholds and exceeded the eutrophic threshold during 2016-2018. Similarly, in 2016-2018 all tributary sites exceeded the ecological threshold of less than 31.25 ug/L. While these are small tributaries and actual loading rates may be low, cumulatively they are having an impact on the phosphorus loading to the lake.
